# Draft School Assessment Report

District: Archuleta County 50 JT

School: Pagosa Springs JHS

Date: Dec 12, 2009

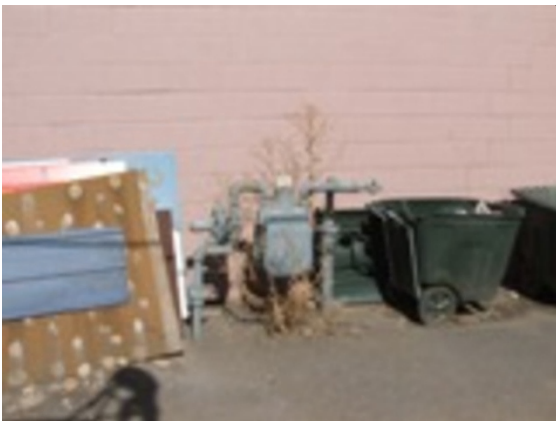
**System:** G2040 - Site Development

**Analysis:** The system age is beyond expected life and showing signs of deterioration. The system may be in service and functioning but it is recommended to be replaced due to increased condition budget and the potential failure of components. The system was installed in 1979. It has a 30-year service life. However, in the assessment, it was found to be currently deficient.

**Condition Budget:** \$70,002

**Recommendation:** The system should be replaced.

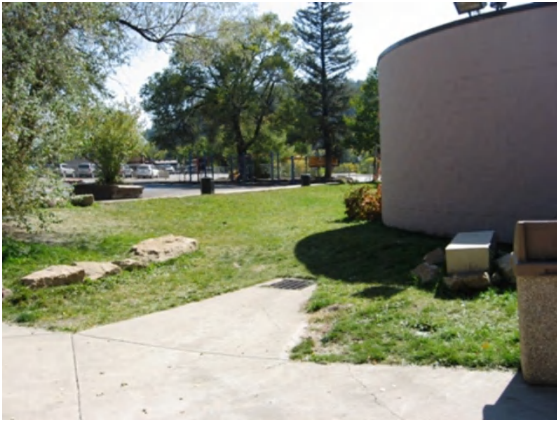
**System:** G2050 - Landscaping

**Analysis:** The system age is beyond expected life and showing signs of deterioration. The system may be in service and functioning but it is recommended to be replaced due to increased condition budget and the potential failure of components. The system was installed in 1999. It has a 10-year service life. However, in the assessment, it was found to be currently deficient.

**Location:** Site  
**Distress:** Beyond Expected Life  
**Category:** Deferred Maintenance  
**Priority:** 3 - Necessary- 2-5 Yrs  
**Correction:** Renew System  
**Qty:** 1-Ea.  
**Condition Budget:** \$246,624

**Recommendation:** The system should be replaced.

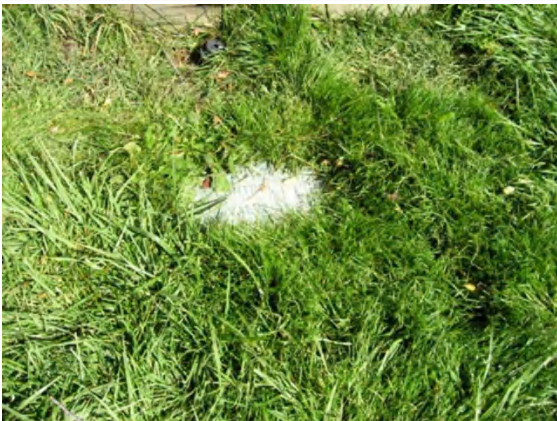
**System:** G3010 - Water Supply

**Analysis:** The system age is beyond expected life and showing signs of deterioration. The system may be in service and functioning but it is recommended to be replaced due to increased condition budget and the potential failure of components. The system was installed in 1954. It has a 50-year service life which expired in 2004.

**Location:** Site  
**Distress:** Beyond Expected Life  
**Category:** Deferred Maintenance  
**Priority:** 3 - Necessary- 2-5 Yrs  
**Correction:** Renew System  
**Qty:** 1-Ea.  
**Condition Budget:** \$40,924

**Recommendation:** The system should be replaced.

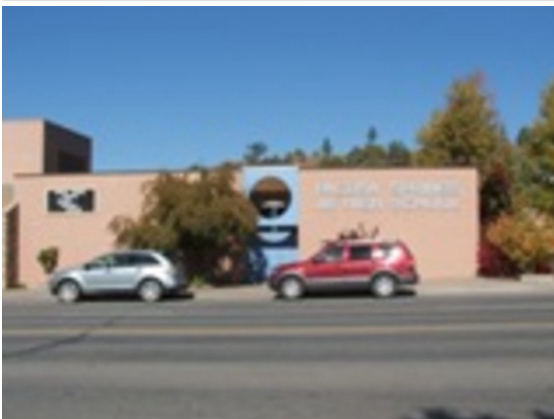
System: G4030 - Site Communication and Security

Analysis: The system is missing.

Location: Site  
Distress: Missing  
Category: Capital Renewal  
Priority: 3 - Necessary- 2-5 Yrs  
Notes: The site has no video surveillance or bollards to stop forced vehicle entry and the systems should be installed.  
Correction: Renew System  
Qty: 1-Ea.  
Condition Budget: \$59,233

Recommendation: The system should be installed.

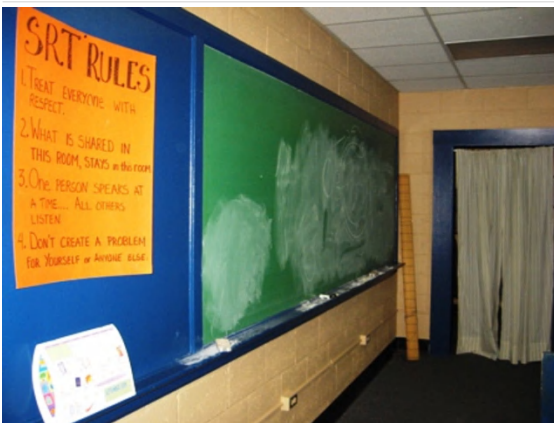
**System:** C1030 - Fittings

**Analysis:** The system age is beyond expected life and showing signs of deterioration. The system may be in service and functioning but it is recommended to be replaced due to increased condition budget and the potential failure of components. The system was installed in 1983. It has a 20-year service life which expired in 2003.

**Condition Budget:** \$127,188

**Recommendation:** The system should be replaced.

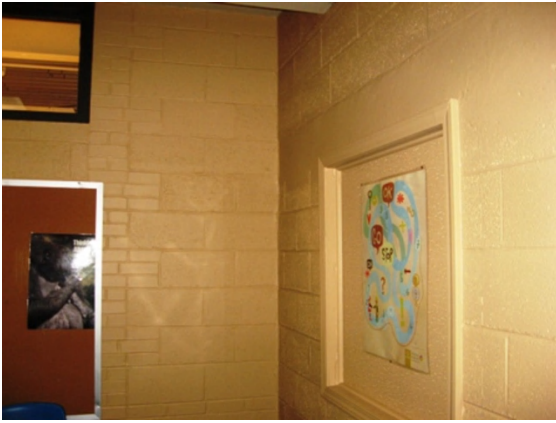
**System:** C3010 - Wall Finishes

**Analysis:** The system age is beyond expected life and showing signs of deterioration. The system may be in service and functioning but it is recommended to be replaced due to increased condition budget and the potential failure of components. The system was installed in 1989. It has a 20-year service life. However, in the assessment, it was found to be currently deficient.

**Location:** Main  
**Distress:** Beyond Expected Life  
**Category:** Deferred Maintenance  
**Priority:** 3 - Necessary- 2-5 Yrs  
**Correction:** Renew System  
**Qty:** 1-Ea.  
**Condition Budget:** \$231,679

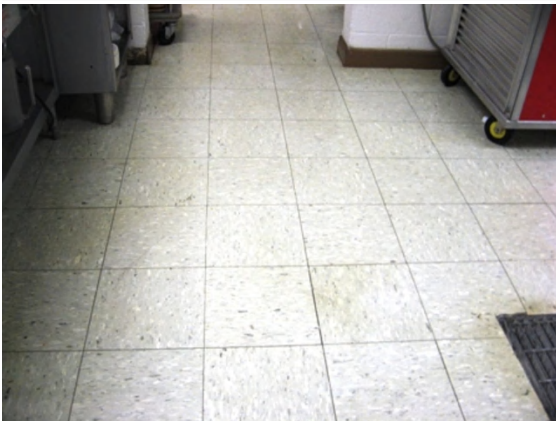
**System:** C3020 - Floor Finishes

**Analysis:** The system age is beyond expected life and showing signs of deterioration. The system may be in service and functioning but it is recommended to be replaced due to increased condition budget and the potential failure of components. The system was installed in 1989. It has a 20-year service life. However, in the assessment, it was found to be currently deficient.

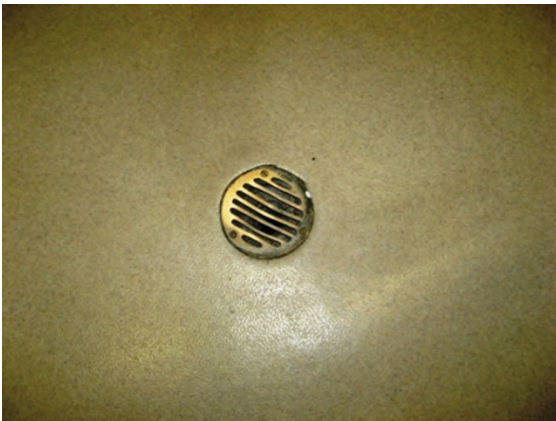
Location: Main  
Distress: Beyond Expected Life  
Category: Deferred Maintenance  
Priority: 3 - Necessary- 2-5 Yrs  
Correction: Renew System  
Qty: 1-Ea.  
Condition Budget: \$87,362

Recommendation: The system should be replaced.

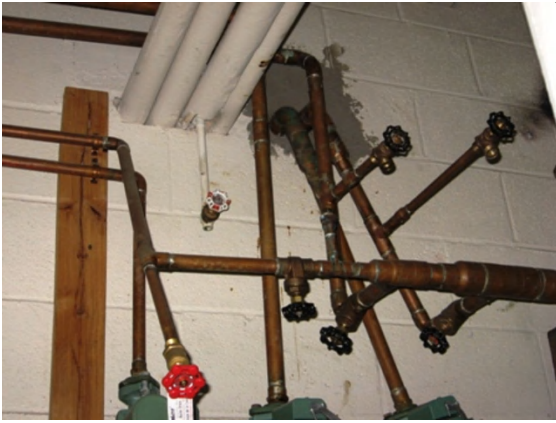
**System:** D2090 - Other Plumbing Systems

**Analysis:** The system age is beyond expected life and showing signs of deterioration. The system may be in service and functioning but it is recommended to be replaced due to increased condition budget and the potential failure of components. The system was installed in 1954. It has a 20-year service life which expired in 1974.

**Location:** Main  
**Distress:** Beyond Expected Life  
**Category:** Deferred Maintenance  
**Priority:** 3 - Necessary- 2-5 Yrs  
**Correction:** Renew System  
**Qty:** 1-Ea.  
**Condition Budget:** \$24,410

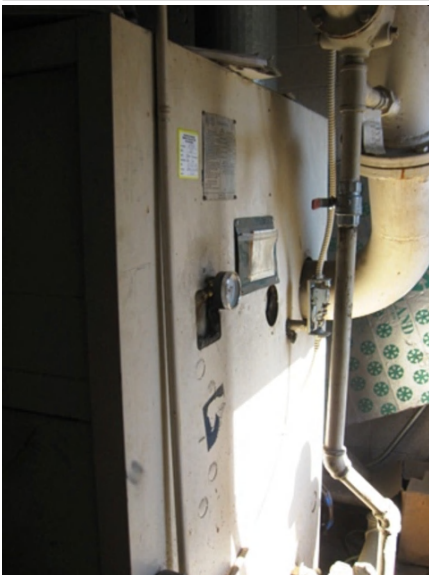
**System:** D3020 - Heat Generating Systems

**Analysis:** The system age is beyond expected life and showing signs of deterioration. The system may be in service and functioning but it is recommended to be replaced due to increased condition budget and the potential failure of components. The system was installed in 1979. It has a 30-year service life. However, in the assessment, it was found to be currently deficient.

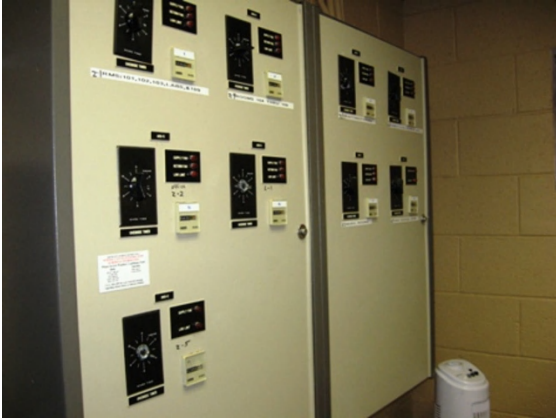
**System:** D3060 - Controls & Instrumentation

**Analysis:** The system age is beyond expected life and showing signs of deterioration. The system may be in service and functioning but it is recommended to be replaced due to increased condition budget and the potential failure of components. The system was installed in 1983. It has a 20-year service life which expired in 2003.

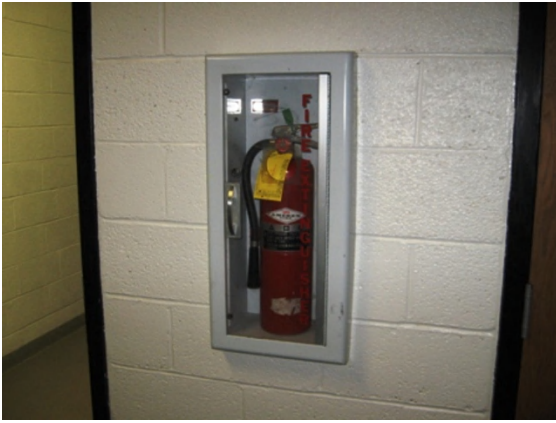
System: D4030 - Fire Protection Specialties

Analysis: The system age is beyond expected life and showing signs of deterioration. The system may be in service and functioning but it is recommended to be replaced due to increased condition budget and the potential failure of components. The system was installed in 1994. It has a 15-year service life. However, in the assessment, it was found to be currently deficient.

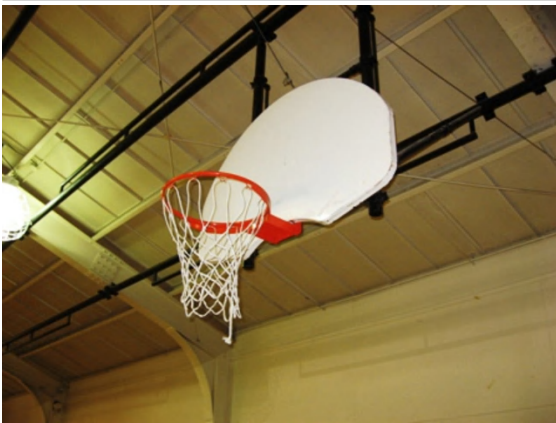
System: E1090 - Other Equipment

Analysis: The system age is beyond expected life and showing signs of deterioration. The system may be in service and functioning but it is recommended to be replaced due to increased condition budget and the potential failure of components. The system was installed in 1954. It has a 20-year service life which expired in 1974.

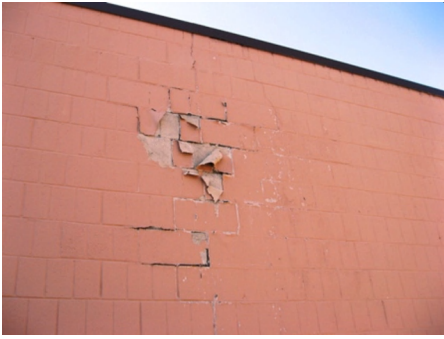
Location: 1983 Add  
Material: Exterior Walls  
Distress: Damaged  
Category: Critical Repair  
Priority: 2 - Potentially Critical-12 months  
Notes: The external walls show some observable cracks and it should be studied by a professional engineer.  
Correction: Professional Structural Engineer  
Qty: 1-Ea.  
Condition Budget: \$25,726

**Recommendation:** The system should be replaced.

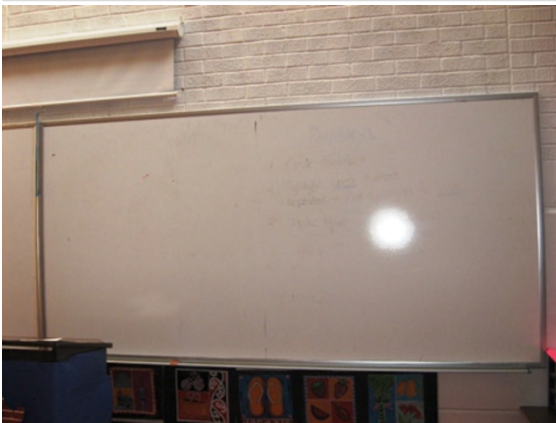
**System:** C1030 - Fittings

**Analysis:** The system age is beyond expected life and showing signs of deterioration. The system may be in service and functioning but it is recommended to be replaced due to increased condition budget and the potential failure of components. The system was installed in 1983. It has a 20-year service life which expired in 2003.

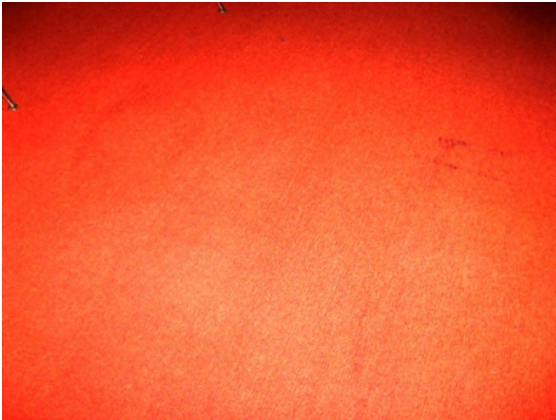
**System:** C3020 - Floor Finishes

**Analysis:** The system age is beyond expected life and showing signs of deterioration. The system may be in service and functioning but it is recommended to be replaced due to increased condition budget and the potential failure of components. The system was installed in 1983. It has a 20-year service life which expired in 2003.

Location: 1983 Add  
Distress: Beyond Expected Life  
Category: Deferred Maintenance  
Priority: 3 - Necessary- 2-5 Yrs  
Correction: Renew System  
Qty: 1-Ea.  
Condition Budget: \$742,781

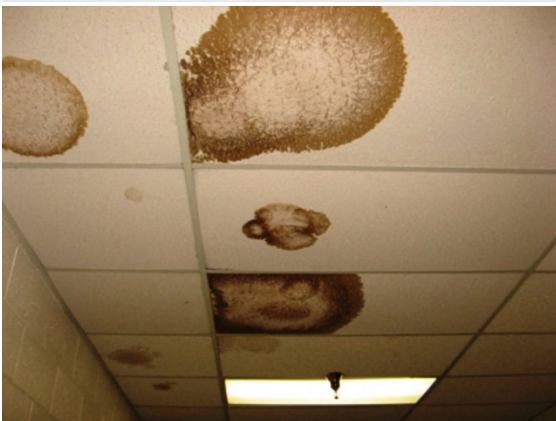
**System:** C3030 - Ceiling Finishes

**Analysis:** The system age is beyond expected life and showing signs of deterioration. The system may be in service and functioning but it is recommended to be replaced due to increased condition budget and the potential failure of components. The system was installed in 1983. It has a 20-year service life which expired in 2003.

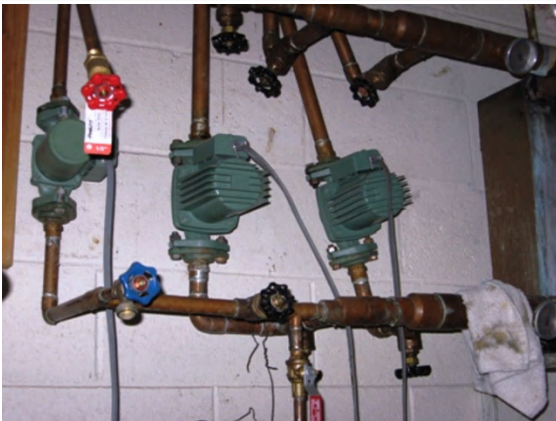
System: D2090 - Other Plumbing Systems

Analysis: The system age is beyond expected life and showing signs of deterioration. The system may be in service and functioning but it is recommended to be replaced due to increased condition budget and the potential failure of components. The system was installed in 1983. It has a 20-year service life which expired in 2003.

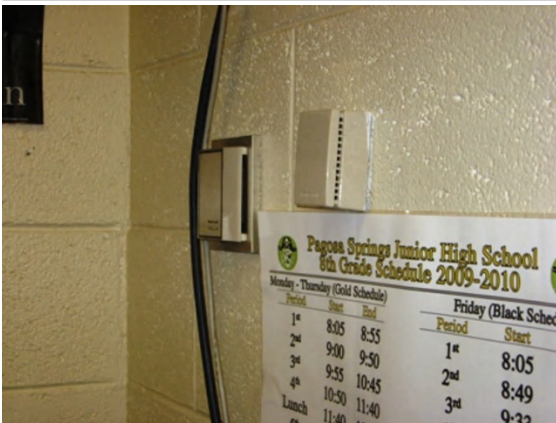
System: D3060 - Controls & Instrumentation

Analysis: The system age is beyond expected life and showing signs of deterioration. The system may be in service and functioning but it is recommended to be replaced due to increased condition budget and the potential failure of components. The system was installed in 1983. It has a 20-year service life which expired in 2003.

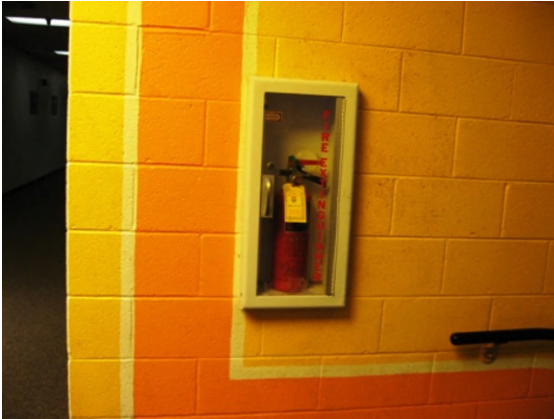
**System:** D4030 - Fire Protection Specialties

**Analysis:** The system age is beyond expected life and showing signs of deterioration. The system may be in service and functioning but it is recommended to be replaced due to increased condition budget and the potential failure of components. The system was installed in 1994. It has a 15-year service life. However, in the assessment, it was found to be currently deficient.

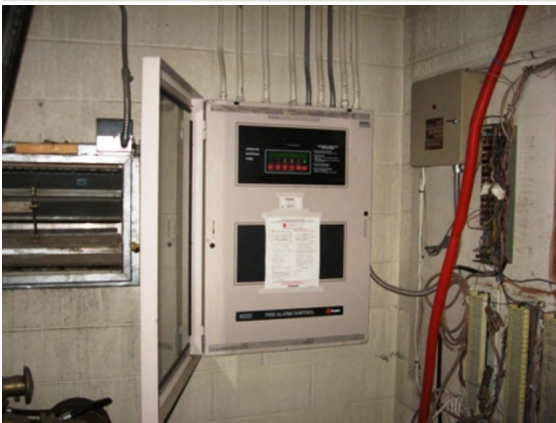
System: D5030 - Communications and Security

Analysis: The system age is beyond expected life and showing signs of deterioration. The system may be in service and functioning but it is recommended to be replaced due to increased condition budget and the potential failure of components. The system was installed in 1983. It has a 20-year service life which expired in 2003.

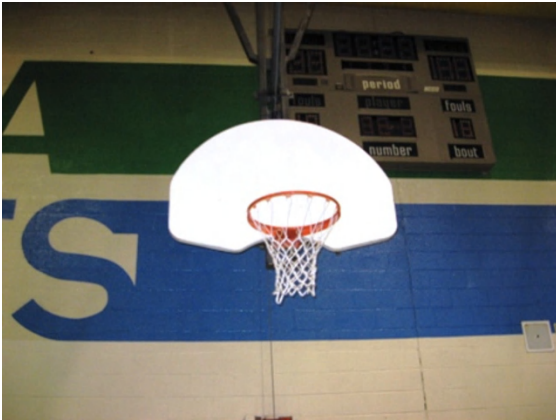
**System:** E1090 - Other Equipment

**Analysis:** The system age is beyond expected life and showing signs of deterioration. The system may be in service and functioning but it is recommended to be replaced due to increased condition budget and the potential failure of components. The system was installed in 1983. It has a 20-year service life which expired in 2003.

Location: 1983 Add  
Distress: Beyond Expected Life  
Category: Deferred Maintenance  
Priority: 3 - Necessary- 2-5 Yrs  
Correction: Renew System  
Qty: 1-Ea.  
Condition Budget: \$75,900

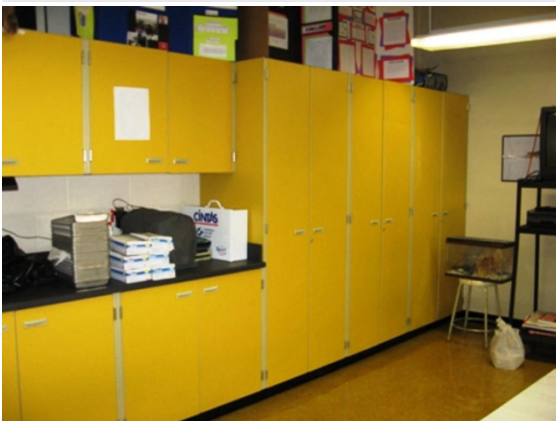
**System:** E2010 - Fixed Furnishings

**Analysis:** The system age is beyond expected life and showing signs of deterioration. The system may be in service and functioning but it is recommended to be replaced due to increased condition budget and the potential failure of components. The system was installed in 1983. It has a 20-year service life which expired in 2003.
